Fatigue Resistance and Structural Integrity of Different Types of Fiber Posts

Simone GRANDINI¹, Nicoletta CHIEFFI², Maria Crysanti CAGIDIACO², Cecilia GORACCI³ and Marco FERRARI¹

¹Department of Endodontics and Restorative Dentistry, University of Siena, Italy

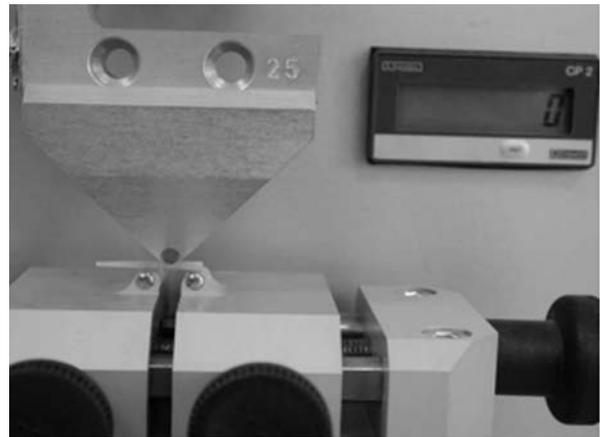
Fig. 1 A post ready to be tested.

Ten posts from each group were tested in a fatigue test machine (Procyon systemes, France). This device had a counter that measured the number of cycles, and that it automatically stopped when the specimen broke (Fig. 1). The three-point bending method of loading was applied, with a loading angle of 90° at a frequency of 3 Hz. All posts were subjected to the same loading conditions. Loading by punch was 20 N at the beginning, and reached 100 N at the end of each cycle. The two supports and the punch had a 3 mm diameter, and distance between the two supports was 9 mm. In tapered posts, the loading punch was positioned on the straight portion of the post. Luscent Anchor posts, which had a conical shape, were loaded at the midpoint of the

post length. All the tests were carried out at a room temperature of approximately 22°C . The machine was set to carry out 2,000,000 cycles. The assumption was that teeth normally come into contact once a minute, and therefore this number of cycles would simulate about four years of physiological occlusal and masticatory activity^{5,7}.

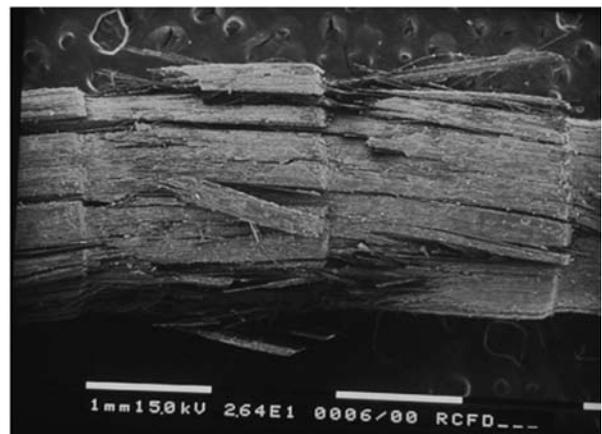
Fig. 4 A sample from Group 3, whereby post was fractured after fatigue test.

When the posts that were fractured after load cycling were observed under SEM, their loss of structural integrity was evident (Fig. 4). On the other hand, the DT Light-Post, GC Fiber Post, and FRC Postec posts, which were able to withstand the fatigue test, exhibited only a small circumferential depression at the area of contact with the loading punch (Fig. 5).
