# Fracture resistance of endodontically treated teeth restored by different FRC posts: An *in vitro* study

Kianoosh Torabi, Farnaz Fattahi

Department of Fixed Prosthodontics, Faculty of Dentistry, Shiraz University of Medical Sciences, Shiraz, Iran

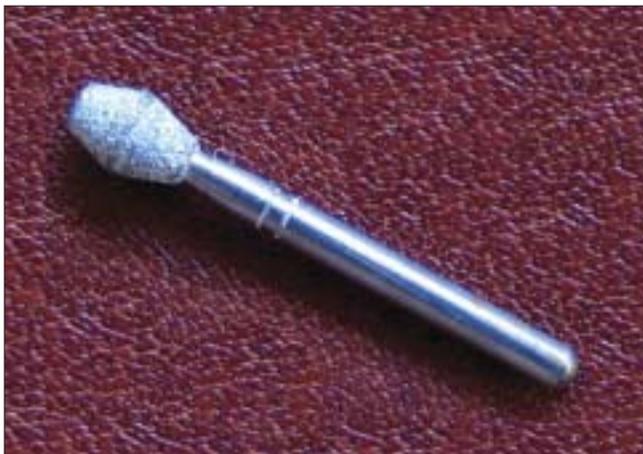
**Figure 1:** Special bar for occlusal surface preparation

A brilliant (Colten AG, Feldwiesenstrasse 20, CH-9450 Altstattea, Switzerland) composite was used to build up the cores of groups 2 to 5. The cores were prepared and finished. For preparation of occlusal surface, a special bur [Figure 1] was used to uniform the occlusal angles of all the specimens which were perpendicular to the tooth long axis during the occlusal surface preparation. All specimens were loaded in a universal testing machine (1026, Instrum Corp, Canton, Mass) at a crosshead speed of 0.5 mm/min until fracture. Load was applied to a small sphere which was placed on the occlusal surface of the prepared teeth at the long axis of the root. Fracture loads and modes were recorded. Tooth fractures were classified as repairable and catastrophic failures [Figures 2-8]. Statistical tests (One Way ANOVA, Fisher's Exact and Tomhan's tests) were used for statistical analysis and a *P* value less than 0.05 was considered significant.

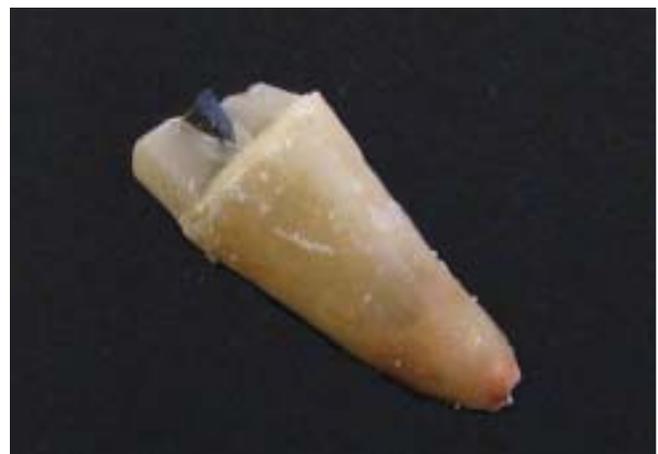
**Figure 2:** Repairable failures (core fracture)

Failure mode group	Repairable (%)				Irreparable (%)		
	Core detachment [Figure 2]	Core and post fracture [Figure 3]	Cervical root fracture [Figure 4]	Middle root fracture [Figure 5]	Apical root fracture [Figure 6]	Vertical root crack [Figure 7]	Horizontal root fracture [Figure 8]
1				40	10	40	10
2	30	30		30		10	
3	30		30	10		20	10
4	20	30		10	10	30	
5	40	10	20	10		20	
Total	24	14	10	20	4	24	4

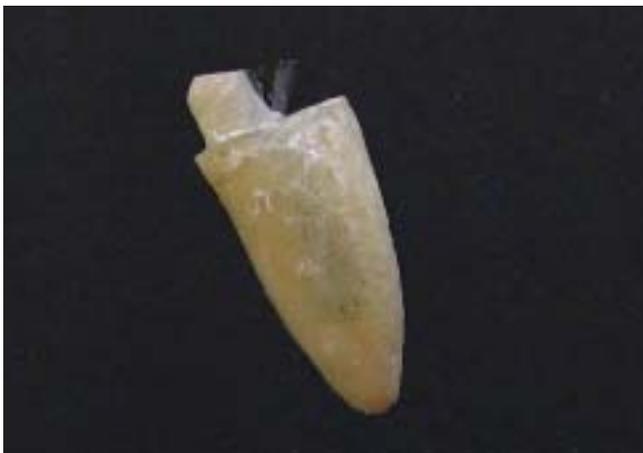
**Figure 3:** Repairable failures (core and post fractures)

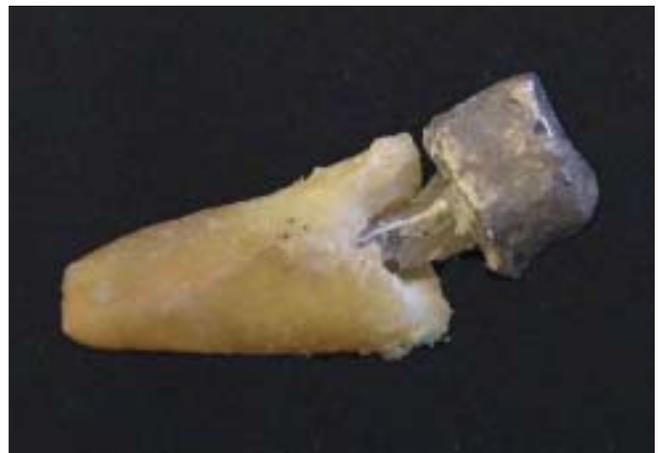
**Figure 4:** Repairable failures (cervical root fracture)

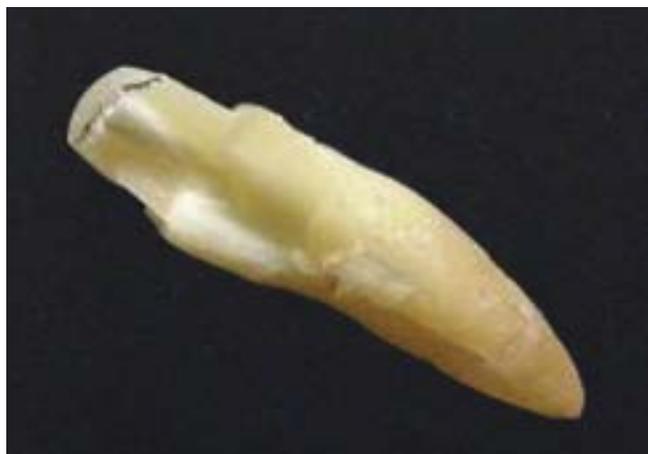
Figure 5: Irreparable failures (middle root fracture)

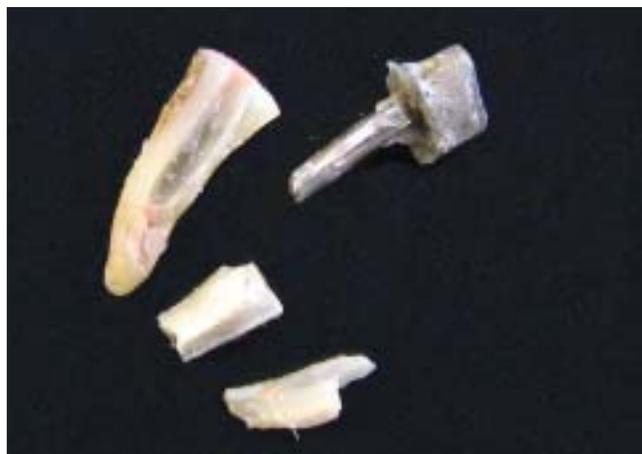
Figure 6: Irreparable failures (apical root fracture)

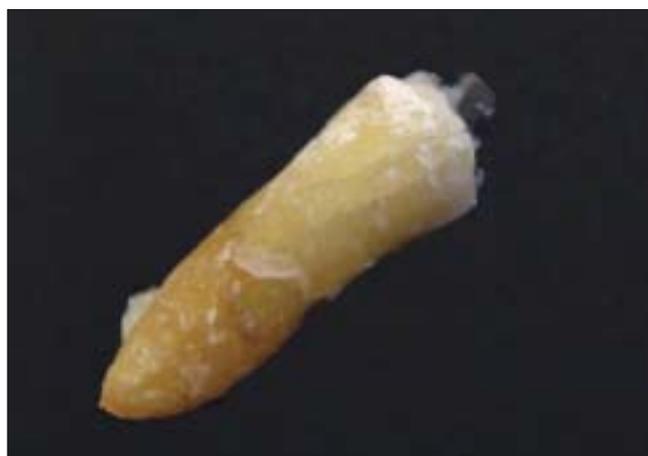
Figure 7: Irreparable failures (vertical crack)

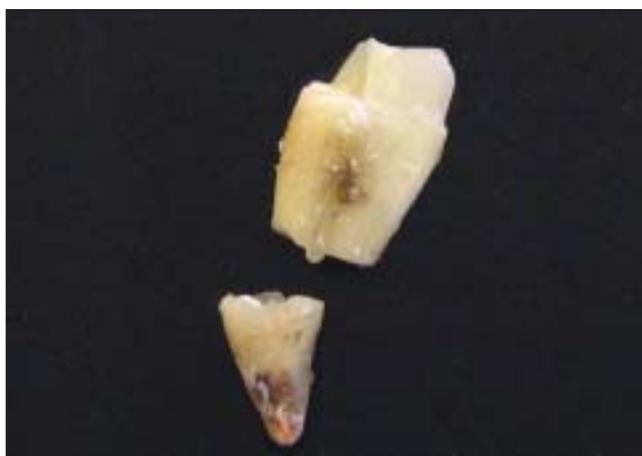
Figure 8: Irreparable failures (horizontal root fracture)
